POLITECNICO DI MILANO  
DIPARTIMENTO DI INGEGNERIA STRUTTURALE  
LABORATORIO PROVE MATERIALI  
PIAZZA LEONARDO DA VINCI, 32 - 20133 MILANO

Certificato di Prova N. 2011/2749 emesso in Milano il 03/11/2011

FATIGUE TESTS ON ANCHORAGE SYSTEM FOR SIKA CARBODUR S626 STRIPS

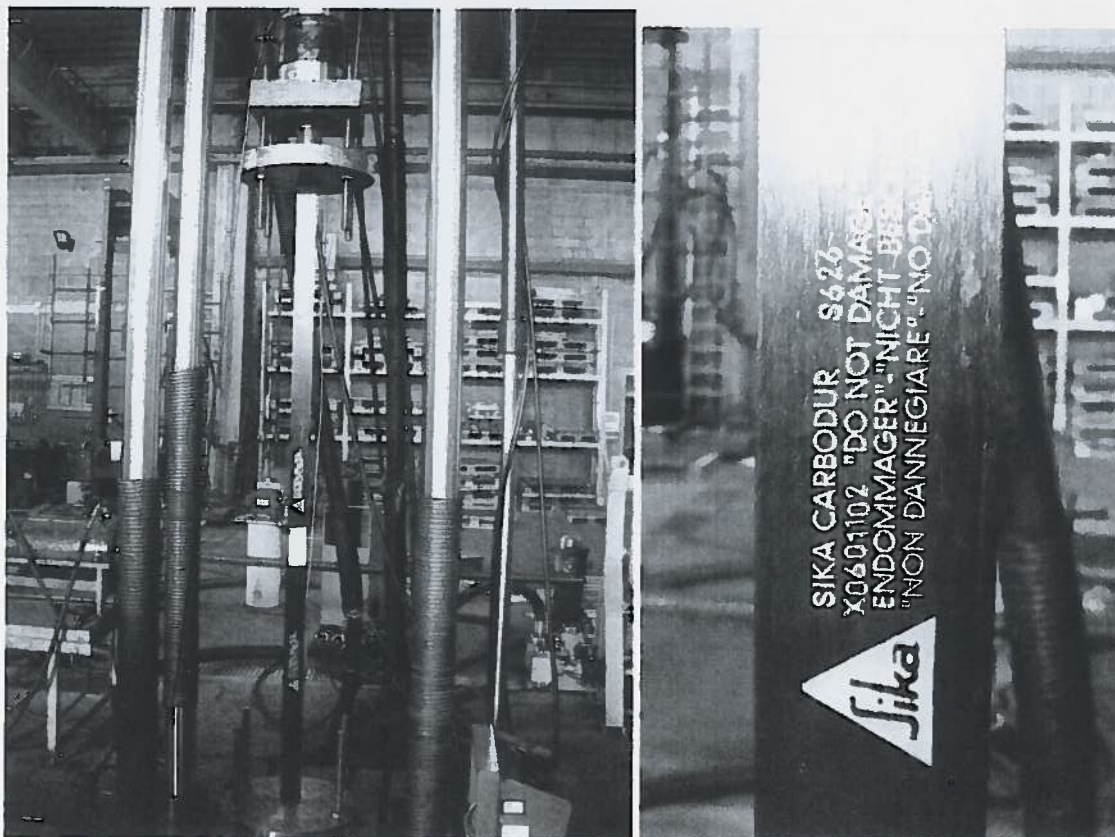
Fig. 1

Specimen was realized by CFRP strips type Sika Carbodur S626 (Fig. 1). The specimen was anchored to the testing machine by CFRP barrels and non metallic wedges (Fig. 2). The characteristics of the CFRP strips, declared by the supplier, are:

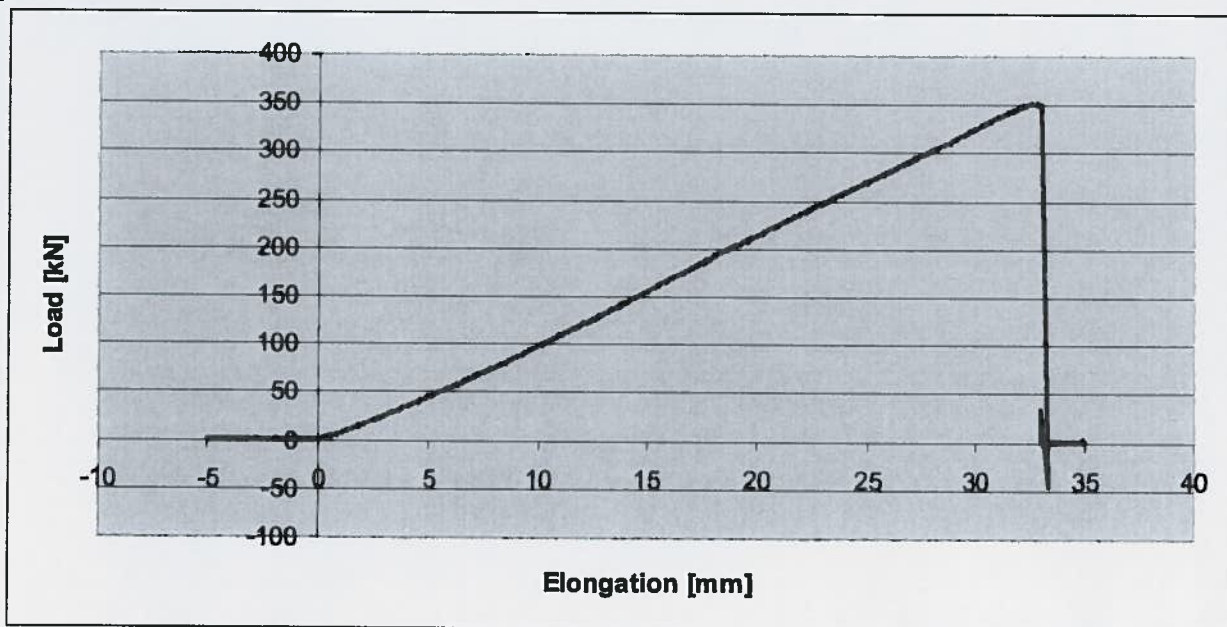
**Specimen n° 2**

Table 1 reports the results of the measurement performed during the fatigue tests. At the end of the fatigue tests no apparent damage of the anchorage was visually observed. The results of failure tests are reported in Table 2. Note that due to a technical problem the failure load and the elongation at failure was not recorded at the end of the first test. The relevant load elongation diagrams are reported in Fig. 3. Static failure was due to brittle fracture of the CFRP strips.

Test	Failure load [kN]	Elongation [mm]
1	-	-
2	348,91	33,04
3	342,93	32,65
